Quarterly Progress Report

Grant #7310006

Arctic Thermal Shutters and Doors

Arctic Sun, LLC

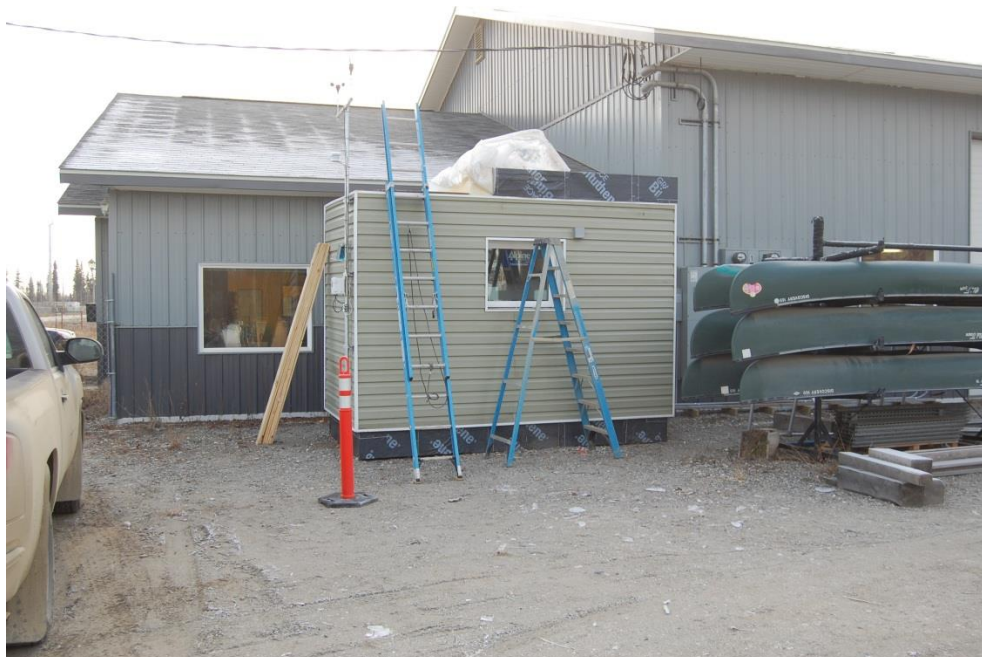
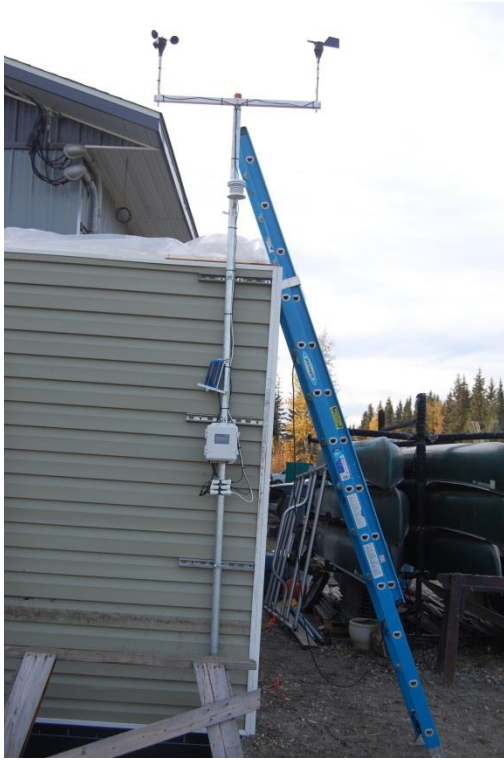
Task 4. Construct testing box; The box was constructed immediately north of our shop, in the sun shadow of our office building (photo below). This location is easily monitored and will essentially eliminate any solar gain influences on the box, and will also minimize wind load. A complete weather-station was installed on the northeast corner of the box, and the single window was installed in the north wall. Standard remote-wall construction techniques were utilized throughout the structure to approximate real-world dynamics. Twelve inches of expanded polystyrene was utilized on the top, bottom and all four sides of the structure.

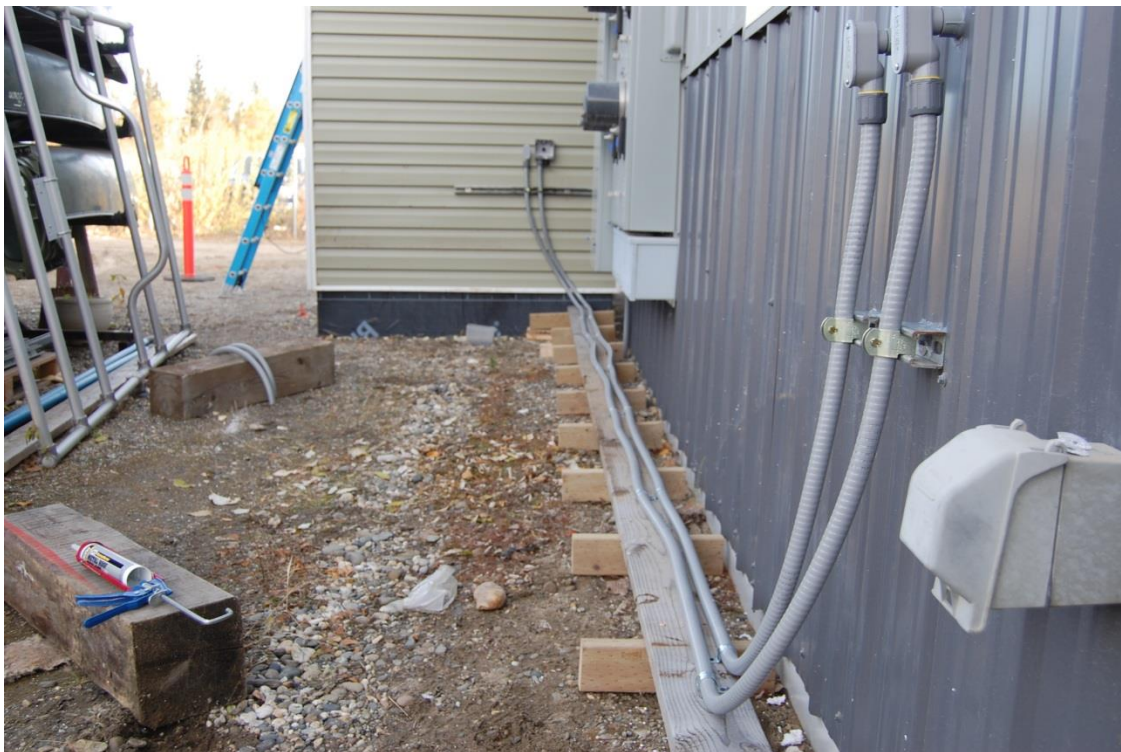
Staff from ACEP inspected the box just before the last few sensors were connected to the data recording system. Two conduits run from the testing box to inside our shop, so all sensors can be monitored remotely without opening or entering the box.

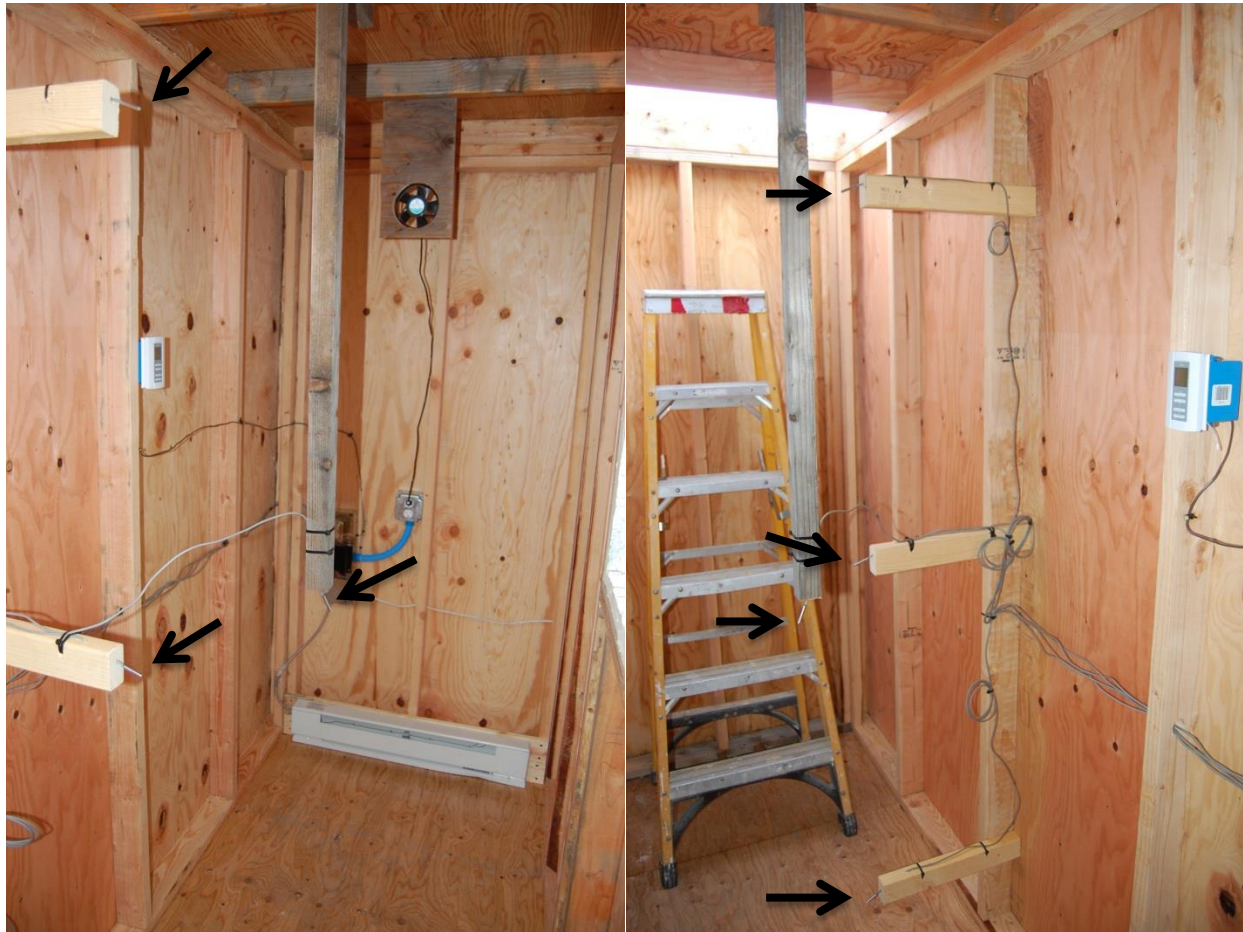
The left photo below shows the inside of the box with several of the temperature sensors (three arrows), the circulation fan, and the 750-watt heater near the floor. The corner of the

window is just visible in the right edge of the photo. The photo on the right shows the ceiling access hatch, all four temperature sensors (arrows) and the thermostat.
